Cisco ASR 9000 Aggregation Services Router ISM Line Card Installation Guide

Installing ISM (Integrated Service Module) Line Cards in the Cisco ASR 9000 Series Router

This guide contains instructions for installing ISM (Integrated Service Module) line cards in the Cisco ASR 9000 Series Aggregation Services Router.

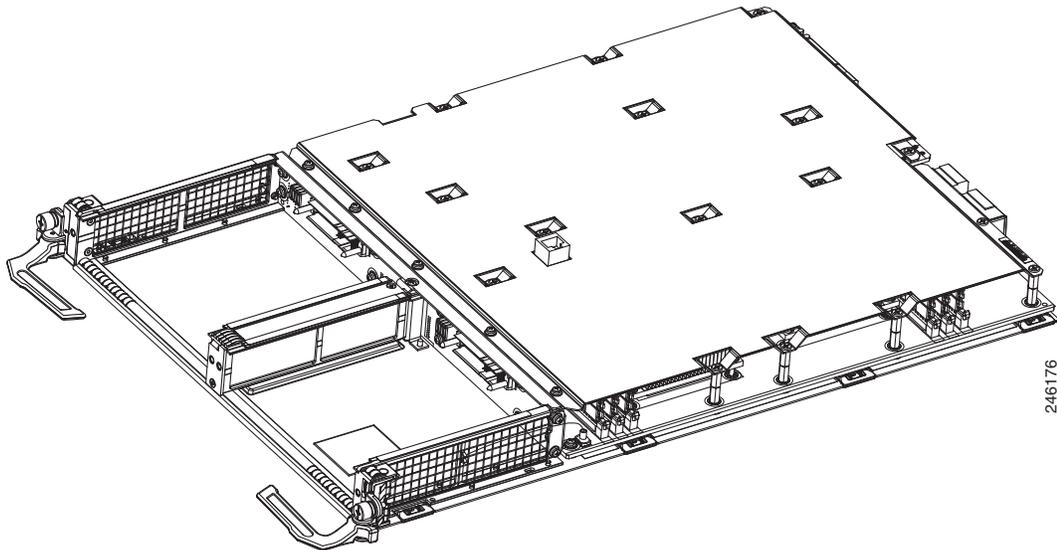
Figure 1-1 ISM (Integrated Service Module) Line Card

An example of the ISM (Integrated Service Module) line card is shown in [Figure 1-1 on page 1-4](#).

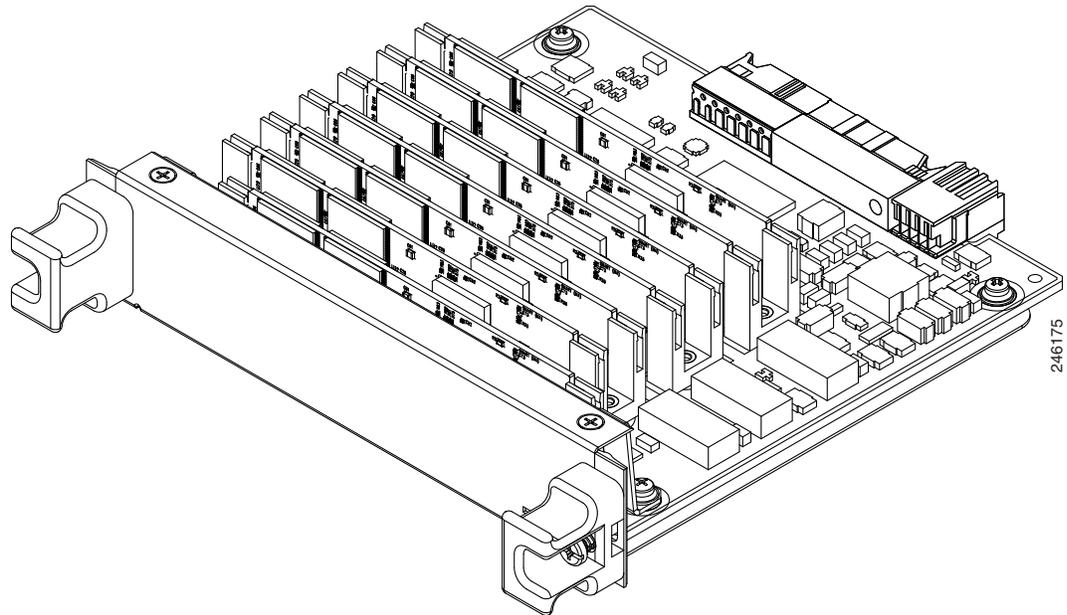
Figure 1-2 Flashback Service Acceleration Module (SAM) Line Card

The Flash Service Acceleration Module (SAM) provides a solid-state based solution for the video cache requirements of the ISM video solution. Each Flash Module provides two terabytes (2 TB) of memory. From this two terabytes, 1.6 terabytes are available as video caching capacity. The remainder is used for wear level of the flash drives. There is a maximum of two SAMs per ISM, thus, the maximum amount of ISM video cache is 3.2 TB cache per ISM slot.

An example of the SAM (Service Acceleration Module) line card is shown in [Figure 1-2 on page 1-5](#).

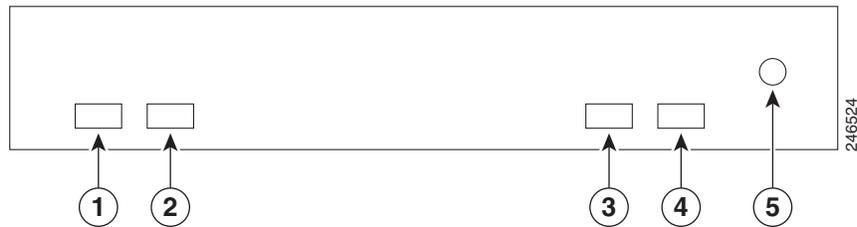
Figure 1-3 Flashback Service Acceleration Module (SAM) Line Card Faceplate

1	SAM Flash Module Fault LED	5	Shutdown Button (recessed to avoid being pressed inadvertently)
2	SAM Flash Module Attention LED		
3	SAM Attention LED		
4	SAM Status LED

There are four LEDs on each Flash Service Acceleration Module (SAM). 2 to the right and 2 to the left. The SAM Status LED and the SAM Attention LED are to the right side of the SAM. The SAM Status LED is to the rightmost and one before that is the SAM Attention LED. The other two LEDs are located to the Left side of SAM. The leftmost is the Flash Module Fault LED and one next to it is Flash Module Active LED. Refer to [Figure 1-3 on page 1-5](#).

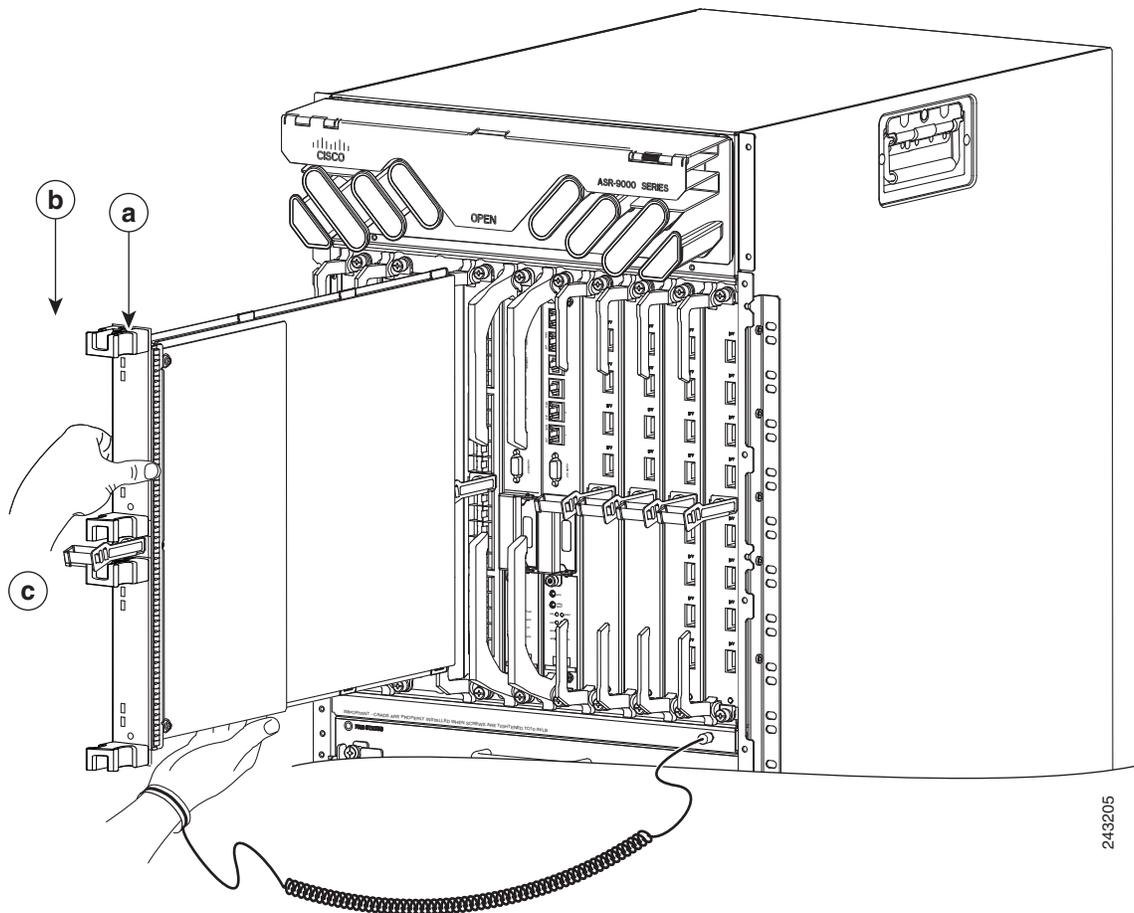
Figure 1-4 Line Card Removal and Installation for the Cisco ASR 9010 Router

If you are replacing a failed line card, remove the existing line card first, then install the new line card in the same slot. To remove a line card, use [Figure 1-4](#) or [Figure 1-5](#) as a reference and follow these steps:

-
- Step 1** Attach an ESD-preventive wrist or ankle strap and follow its instructions for use.
 - Step 2** Disconnect and remove all interface cables from the ports; note the current connections of the cables to the ports on the line card.
 - Step 3** Detach the line card cable-management bracket from the line card.
 - Step 4** Use a screwdriver to loosen the captive screw at each end of the line card faceplate (see [Figure 1-4a](#) or [Figure 1-5a](#)).

- Step 5** Simultaneously pivot the ejector levers away from each other to release the line card from the backplane connector (see [Figure 1-4b](#) or [Figure 1-5b](#)).

- Step 6** Grasp the ejector levers and pull the line card halfway out of the slot.
- Step 7** Grasp the line card and gently pull it straight out of the slot, keeping your other hand under the line card to guide it (see [Figure 1-4c](#) or [Figure 1-5c](#)). Avoid touching the line card printed circuit board, components, or any connector pins.

Grasp the faceplate of the line card with one hand and place your other hand under the metal card carrier to support the weight of the card (see [Figure 1-4](#) or [Figure 1-5](#)). Position the card for insertion into the card cage slot. Avoid touching the line card printed circuit board, components, or any connector pins.

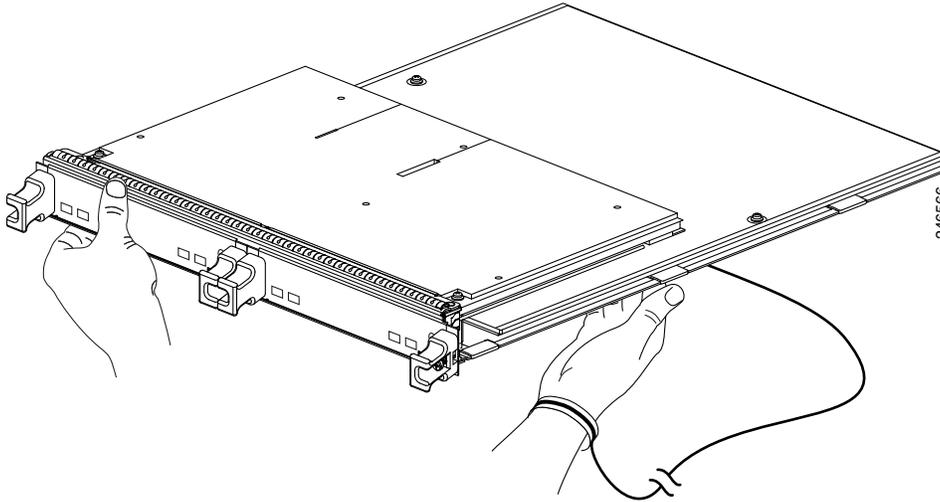
Figure 1-6 Handling an ISM (Integrated Service Module) Line Card

Always handle the ISM (Integrated Service Module) line card by the carrier edges and handle; never touch the ISM (Integrated Service Module) line card components or connector pins. (See [Figure 1-9](#).)

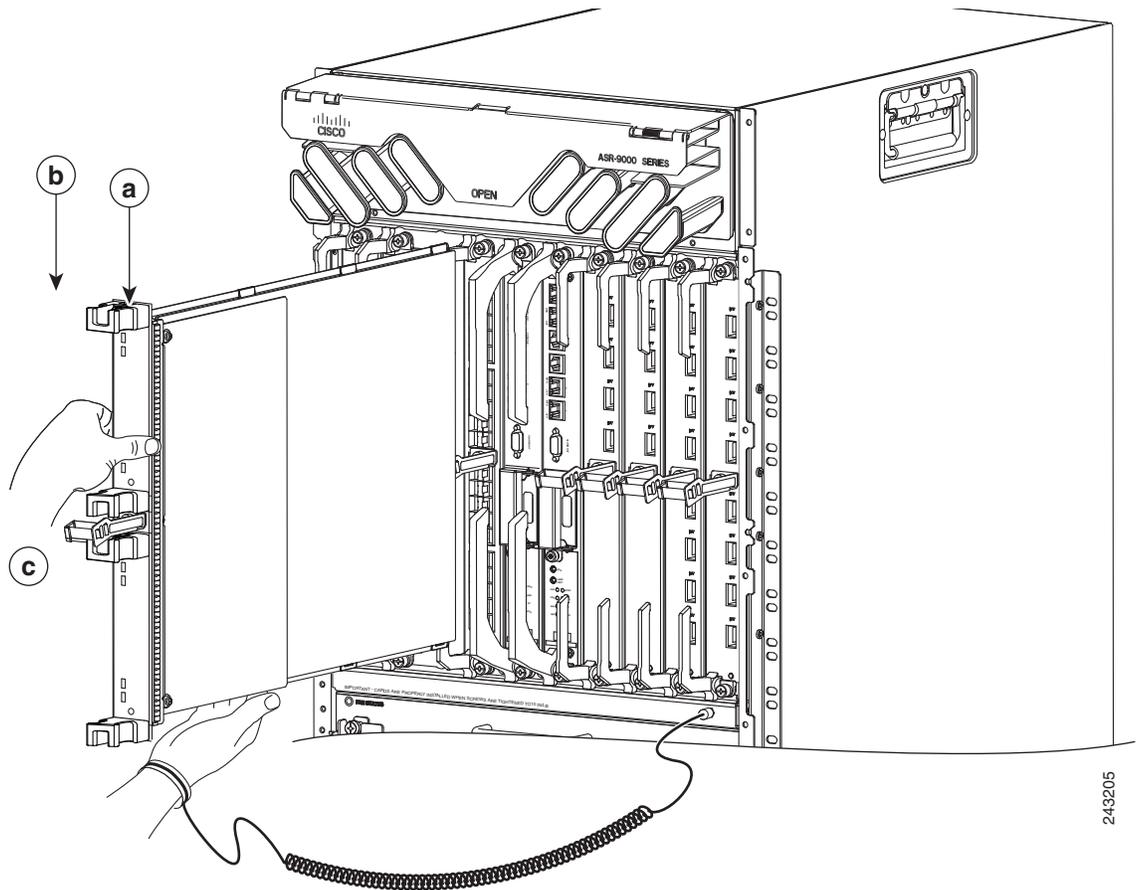
Figure 1-7 ISM (Integrated Service Module) Line Card Removal and Installation

If you are replacing a failed ISM (Integrated Service Module) line card, remove the existing ISM (Integrated Service Module) line card first, then install the new ISM (Integrated Service Module) line card in the same slot. To remove an ISM (Integrated Service Module) line card, use [Figure 1-4](#) as a reference and follow these steps:

- Step 1** Attach an ESD-preventive wrist strap and follow its instructions for use.
- Step 2** Use a screwdriver to loosen the captive screw at each end of the ISM (Integrated Service Module) line card faceplate. (See [Figure 1-8](#).)

- Step 4** Grasp the ejector levers and pull the ISM (Integrated Service Module) line card halfway out of the slot.
- Step 5** Grasp the ISM (Integrated Service Module) line card and gently pull it straight out of the slot, keeping your other hand under the ISM (Integrated Service Module) line card to guide it. (See [Figure 1-7](#).) Avoid touching the ISM (Integrated Service Module) line card printed circuit board, components, or any connector pins.

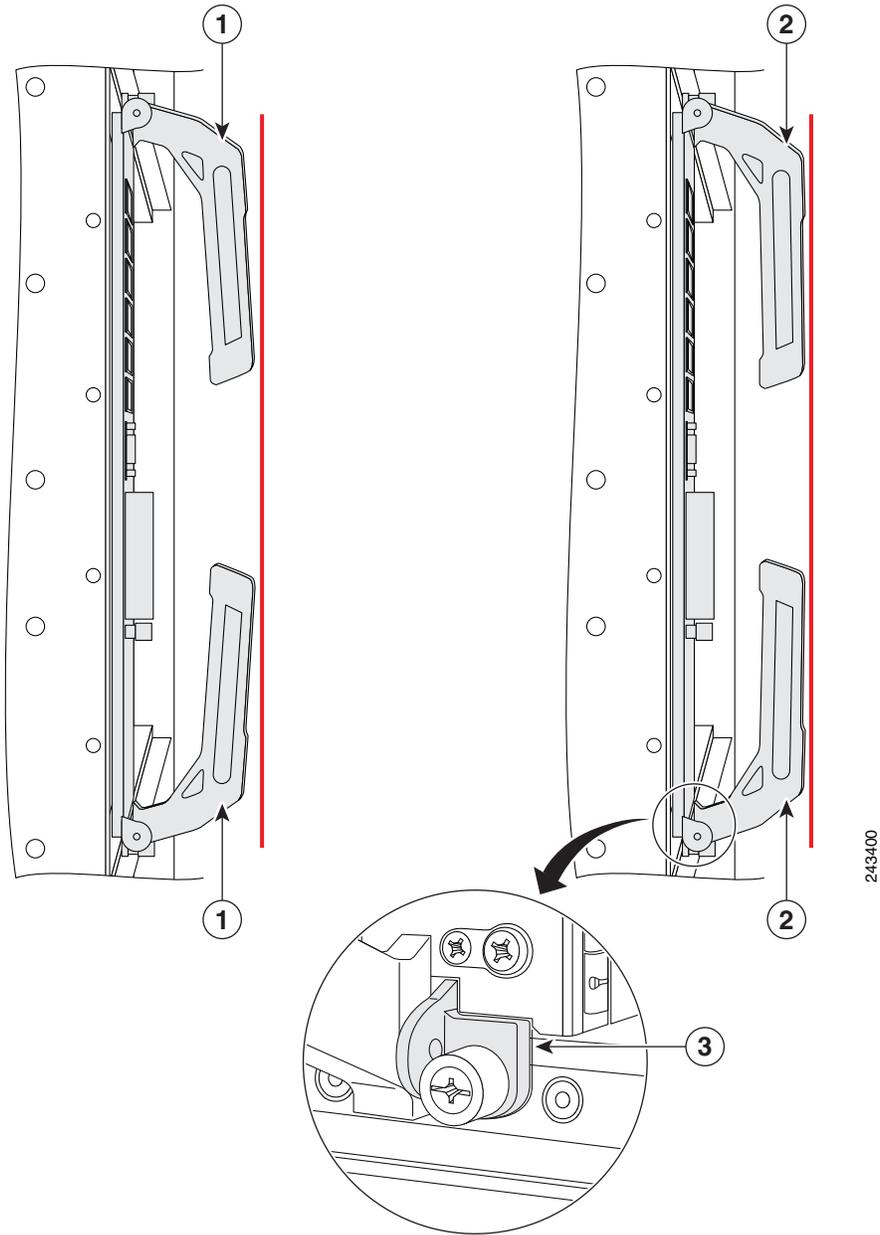
Figure 1-8 ISM (Integrated Service Module) Card Ejector Lever Positions During Installation

Note: Vertical red lines in [Figure 1-8](#) indicate a line fully parallel to the ISM (Integrated Service Module) card front panel.

<p>1 Slightly loose position of ejector levers when the ISM (Integrated Service Module) card is fully seated in the backplane, but the captive installation screws are not fully tightened</p>	<p>2 Fully parallel position of ejector levers when the ISM (Integrated Service Module) card is fully seated in the backplane and captive installation screws are fully tightened</p>	<p>3 Slight gap that may be present when the ISM (Integrated Service Module) card is fully seated in the backplane and captive installation screws are fully tightened</p>
---	--	---

- Step 3** Simultaneously pivot the ejector levers away from each other to release the ISM (Integrated Service Module) line card from the backplane connector. (See [Figure 1-8](#).)

Carefully slide the ISM (Integrated Service Module) line card into the slot until the ejector levers make contact with the edges of the card cage, then *stop* when the ejector lever hooks catch the lip of the card cage. If they do not catch, try reinserting the ISM (Integrated Service Module) line card until the ejector lever hooks are fully latched. (See [Figure 1-8](#).)

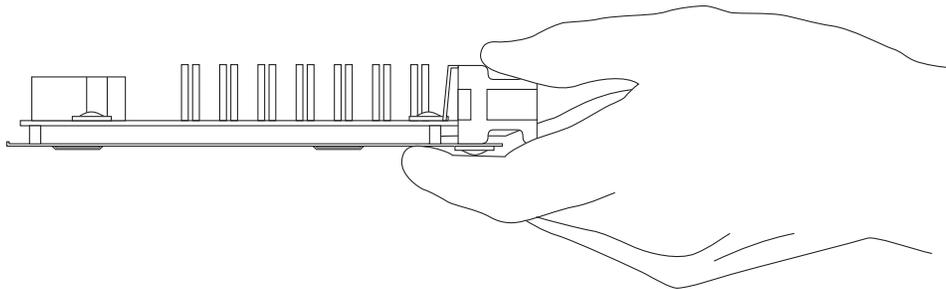
Figure 1-9 Handling a SAM (Service Acceleration Module)

Always handle the SAM (Service Acceleration Module) by the carrier edges and handle; never touch the SAM (Service Acceleration Module) components or connector pins. (See [Figure 1-9](#).)

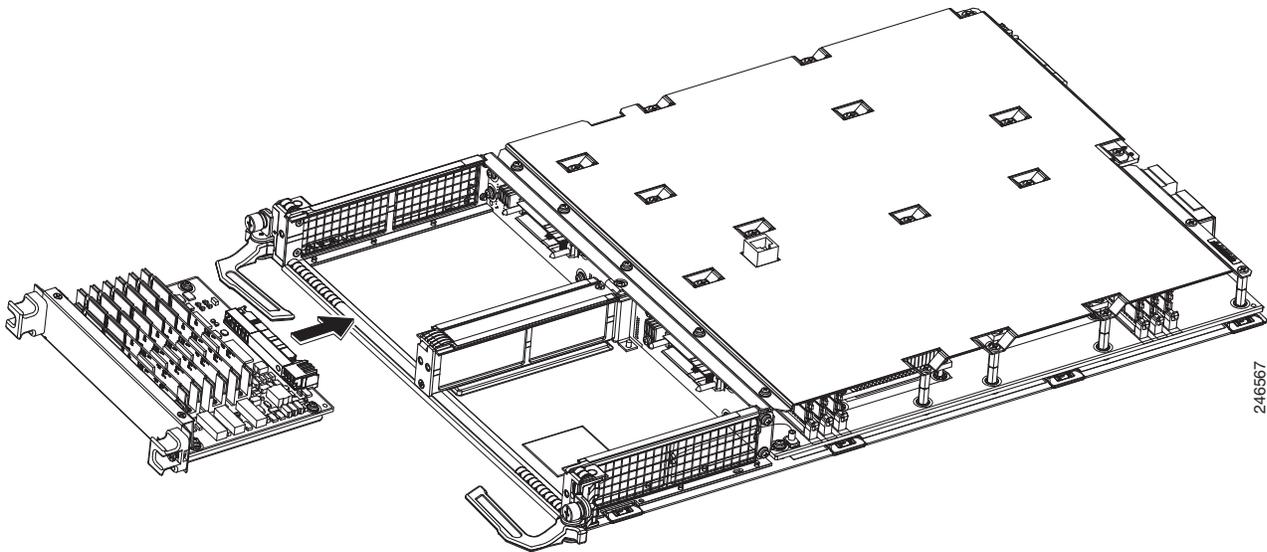
Figure 1-10 SAM (Service Acceleration Module) Installation and Removal

To remove and install a SAM (Service Acceleration Module) in an ISM (Integrated Service Module) line card, refer to [Figure 1-10](#) and do the following:

- Step 1** To insert the SAM (Service Acceleration Module) in the ISM (Integrated Service Module) line card, locate the guide rails inside the ISM (Integrated Service Module) line card that hold the SAM (Service Acceleration Module) in place. They are at the top and bottom of the SAM (Service Acceleration Module) slot and are recessed about an inch, as shown in C of [Figure 1-10](#).

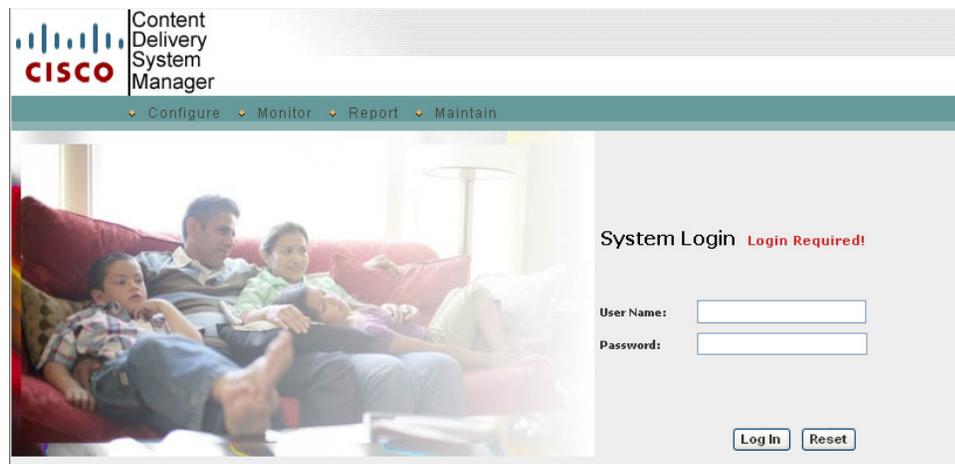
Figure B-1 CDSM Login Page

The System Login page is displayed (see [Figure B-1](#)).

Step 4 Log in to the CDS manager GUI. Enter *admin* as the user name and *admin* as the password and click **Login**.
